GROUNDSTATE
ENVIRONMENTAL

ROOF FINDINGS & RECONCILIATION

Request for carrier reinspection

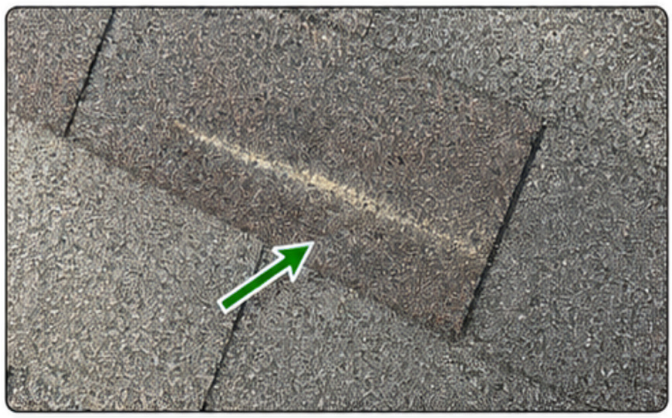
Directional creasing along shingle tab

DIRECTIONAL CREASING ALONG TAB

Patterned uplift across slope

PATTERNED UPLIFT ACROSS SLOPE

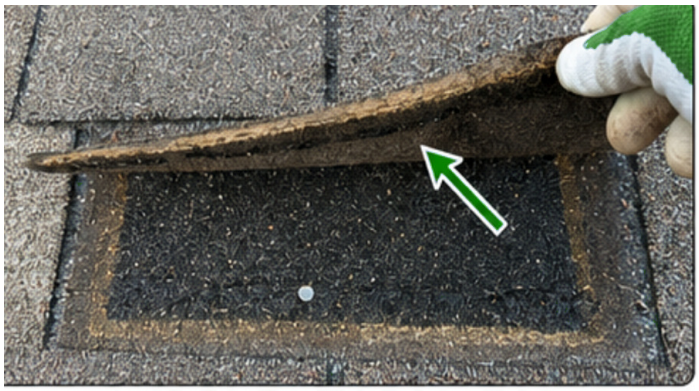
Lifted tab with failed sealant bond

LIFTED TAB WITH FAILED SEALANT BOND

Repeated wind-stress indicators on field shingles

REPEATED WIND-STRESS INDICATORS

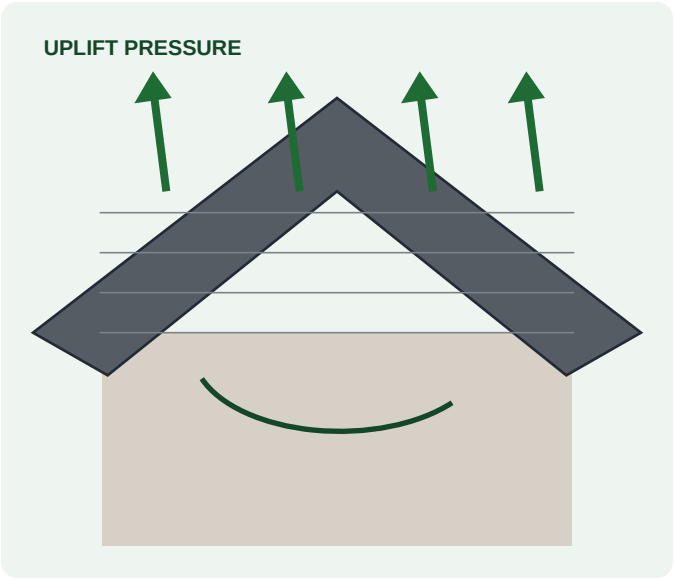
WIND UPLIFT MECHANISM

- Wind pressure acts on exposed shingle tabs.
- Sealant adhesion may break or weaken.
- Tabs can lift, flex, crease, and lose weather-tightness.
- Resulting openings can create an intrusion pathway.
